HOWARD COUNTY HISTORIC PRESERVATION COMMISSION

December Agenda

Thursday, December 1, 2016; 6:30 p.m.

16-103 – 8386 Court Avenue, Ellicott City

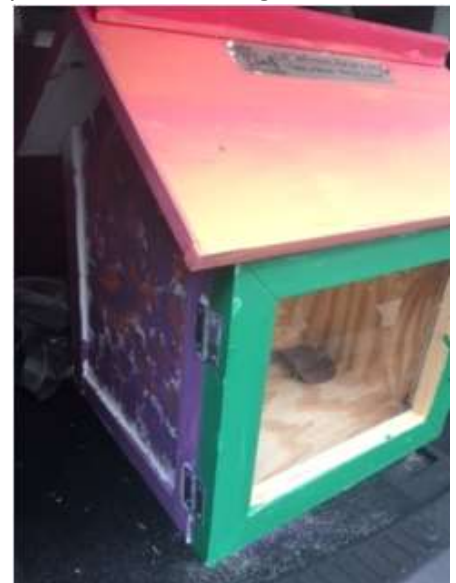
Figure 1 - Proposed 'Little Free Library' to be installed

The library stand complies with Chapter 10.C recommendations, “use street furniture that is simple in design and constructed of traditional materials such as wood and dark metal.” The proposed library stand will be made from wood, although it has been painted. The paint colors do not comply with Chapter 6.N of the Guidelines, “use colors that are generally compatible with (and do not clash with) the colors used in the district, particularly on neighboring buildings...In general, use calm or subdued colors, reserving bright colors for small, important details, such as doors or trim.” The colors used are not compatible with the colors used in the district. The Guidelines also specifically recommend against, “using primary colors, bright orange, bright purple and grass green. These are not historically appropriate and generally will blend with the district’s architecture” and “using too many colors. This may detract from the architectural design of the building.” There are about four to five different colors used on the library stand and all are bright colors. The colors do not comply with the Guidelines.

Staff Recommendation: Staff recommends Approval of the library stand, contingent upon using an alternate color scheme with historically appropriate colors. Staff recommends the color scheme be subject to Staff approval, with guidance provided by the Commission.

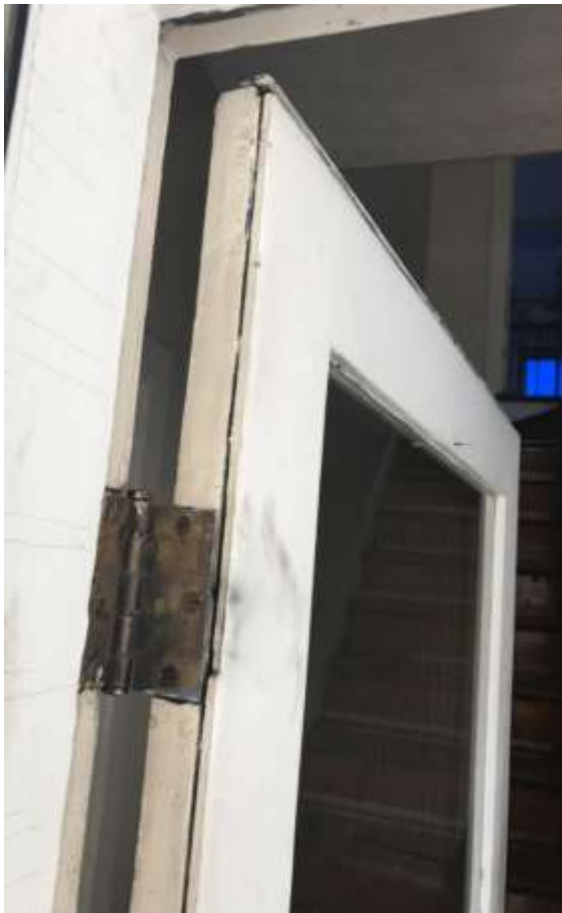
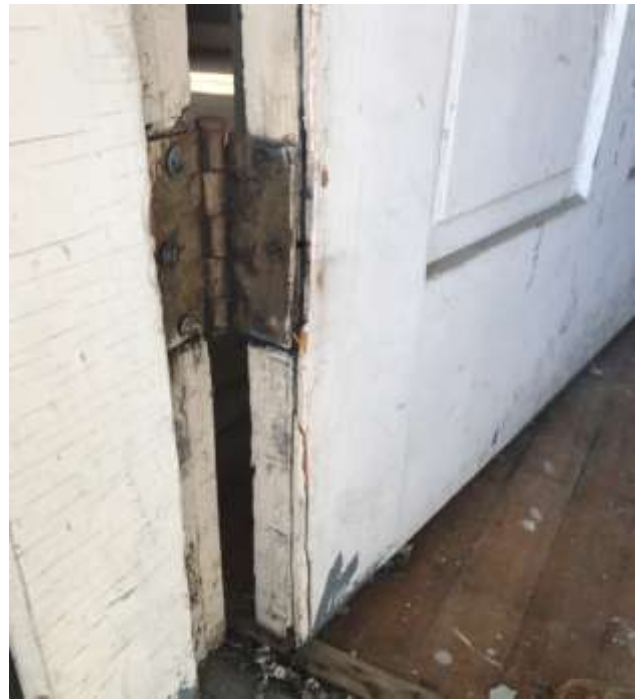
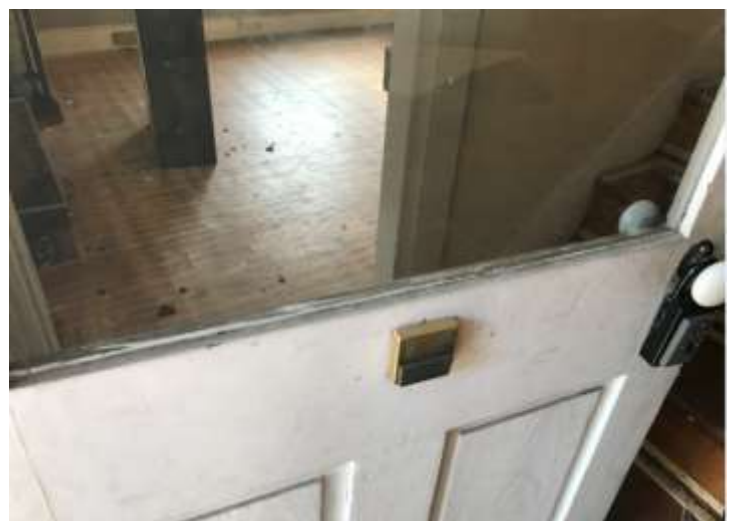
Figure 10 - Front door

Front doors - The front door does not appear to be damaged beyond repair. It is located under a porch and was covered with a storm door so it should not be in so poor of a condition that repair would not be possible. Staff requested additional photographs showing damage and the Applicant has submitted the photos shown in Figures 10-12 below. Staff recommends denial of replacement front door and recommends the door be repaired and tax credit pre-approval for the work.

- 1) Denial of replacement of the front door and recommends the door be repaired and tax credit pre-approval for the work.
- 2) Approval of the replacement of the side basement door and tax credit pre-approval for the work.

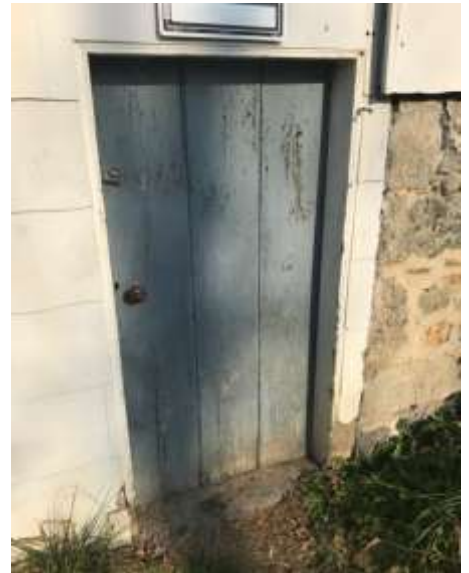
Figure 13 – South west wood side door

Side basement door - The wood side door on the south west side of the house was not mentioned in application, so Staff followed up through email. The Applicant stated the door will be replaced with the same material and style. The paint color needs to be determined. See Figure 13. The bottom of the door does appear to be deteriorated, but other deterioration is not overly evident. The door is not of a historic style, and Staff has no objection to installing a replacement door to be made of wood and of the same design and style, which is considered Routine Maintenance per Chapter 6.H of the Guidelines, “replace entrance features with materials that exactly match the existing materials.” Staff recommends Approval of the replacement of the side basement door and tax credit pre-approval for the work.

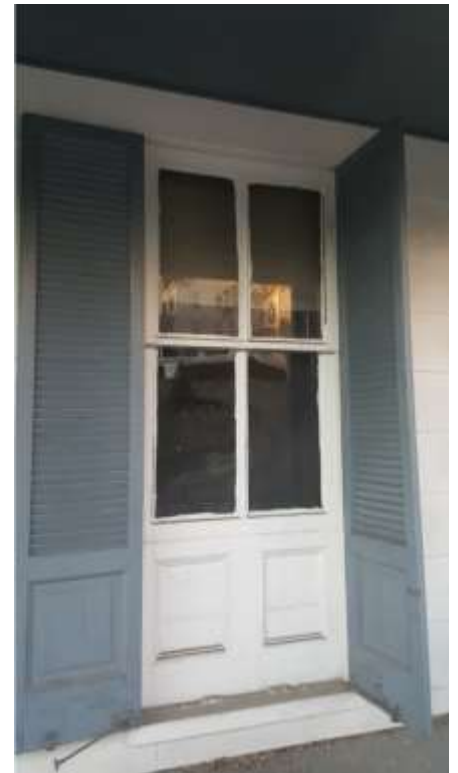
- 2) Windows – Chapter 6.H of the Guidelines recommends maintaining and repairing original windows, but that when repair is not possible, “replace original windows, frames and related details with features that fit the original openings and are of the same style, material, finish and window pane configuration. If possible, reproduce frame size and profile and muntin detailing.” The photos submitted show a lot of rot in the existing windows, many of which appear beyond repair. The proposed windows are 2:2 wood windows, to match the existing windows. Staff recommends Approval of the replacement windows, except for the windows on the front façade. The first floor porch windows are quite large and set above a two panel insert and appear in good condition. The paint has completely sealed the windows and the windows are covered by the porch. The second floor windows should also be repaired if possible, so that the front façade remains historically intact. Otherwise, Staff has no objection with the remainder of the windows being replaced so that the building has one uniform style of window. The size of the replacement windows should comply with the Guidelines referenced above – the profile of the muntins should match and all windows should be sized to their opening, rather than having any openings filled in to fit a stock sized window. Staff recommends approval and tax credit pre-approval for the in-kind replacement of the existing wood windows with new wood windows, but that the front façade windows should be repaired. Staff recommends tax credit pre-approval for the repair of the front façade windows.

Figure 14 - Front porch window

- 3) Approval and tax credit pre-approval for the in-kind replacement of the existing wood windows with new wood windows, except for the front façade windows which should be repaired. Staff recommends tax credit pre-approval for the repair of the front façade windows and for the remainder of the windows to be replaced.

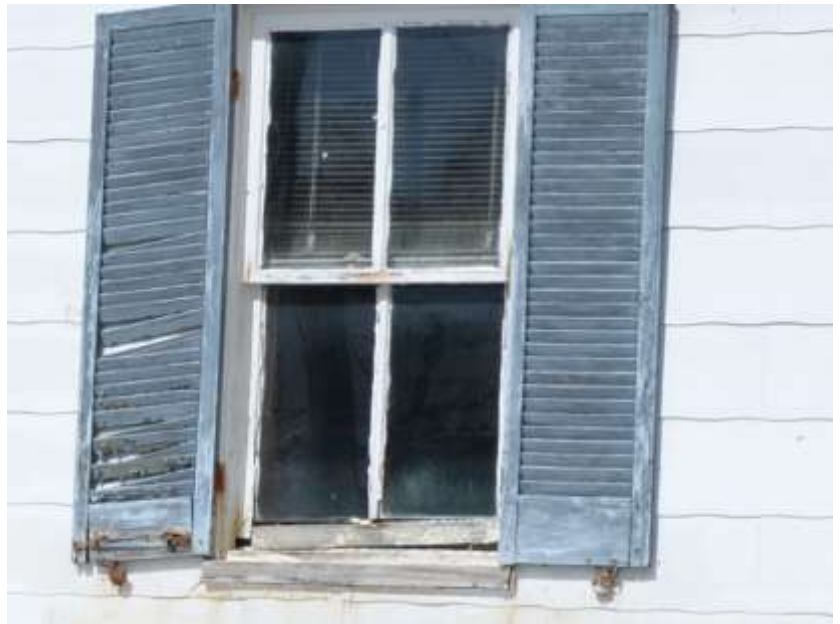
- 6) Shutters – The repair and painting of the shutters and in-kind replacement is considered Routine Maintenance per Chapter 6.I, which states that Routine Maintenance includes, “maintaining and repairing shutters or blinds” and “installing new shutters or blinds that exactly match the existing one.” The Applicant stated the missing shutters have a piece of the metal hinges still on the siding to show that shutters previously existed. Chapter 6.I recommends, “install shutters or blinds of painted wood. Shutters or blinds should be correctly sized for the window and operable, or at least appear operable with hinges and holdbacks appropriate to the period of initial construction.” Any new

Figure 16 - Condition of shutters

shutters should comply with these Guidelines. Staff is unsure if all of the shutters are repairable, in which case Staff recommends they be replaced in-kind with new shutters, to comply with the Guidelines. Staff recommends Approval of repairing the existing shutters or the in-kind replacement with operable, wood shutters if needed, to match the existing for tax credit pre-approval. Staff recommends the front porch shutters be repaired as proposed and not replaced as the panel detail on the shutters matches up perfectly with the panel detail on the window. Staff recommends denial of vinyl shutters, which do not comply with the Guidelines.

- 6) Denial of replacement with the inverted v seam roof.
- 7) Approval of repairing the existing shutters or the in-kind replacement with operable, wood shutters if needed, to match the existing for tax credit pre-approval. Staff recommends the front porch shutters be repaired as proposed and not replaced as the panel detail on the shutters matches up perfectly with the panel detail on the window. Staff recommends denial of vinyl shutters, which do not comply with the Guidelines.

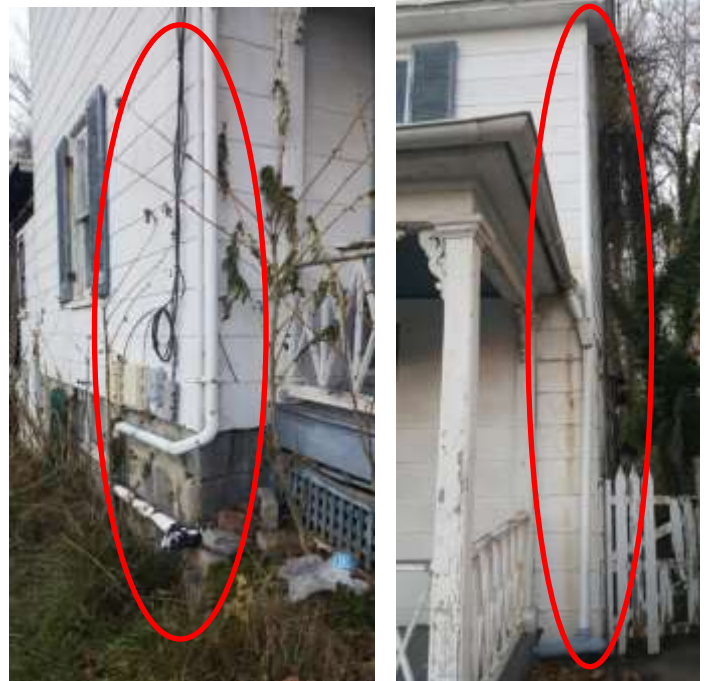
- 7) Gutters - The Applicant has not indicated whether the gutters will be half round or K style. Staff recommends half round gutters be used, which are more historically appropriate as K style gutters are a post war style. The existing gutters around the porch are half round style. The Applicant has also not indicated where the downspouts will be located, but there are existing downspouts on the front corners of the house. The join between these two systems is somewhat clunky and should be refined when new gutters and downspouts are added. Pending location and style, the use of gutters complies with Chapter 6.E recommendations, “use gutters and downspouts of painted metal or prefinished aluminum in a color consistent with the building’s exterior walls or trim. Staff recommends the downspouts be located on the side corners of the house, as recommend by Chapter 6.E of the Guidelines, “Locate downspouts along natural vertical lines and corners of the building.”

Figure 17 - Existing gutters and downspouts

- 8) Approval of installing half round white aluminum gutters, pending appropriate locations being identified. Tax credit pre-approval for the work.
- 9) Denial of driveway expansion. Approval of repaving in asphalt, to match the existing.

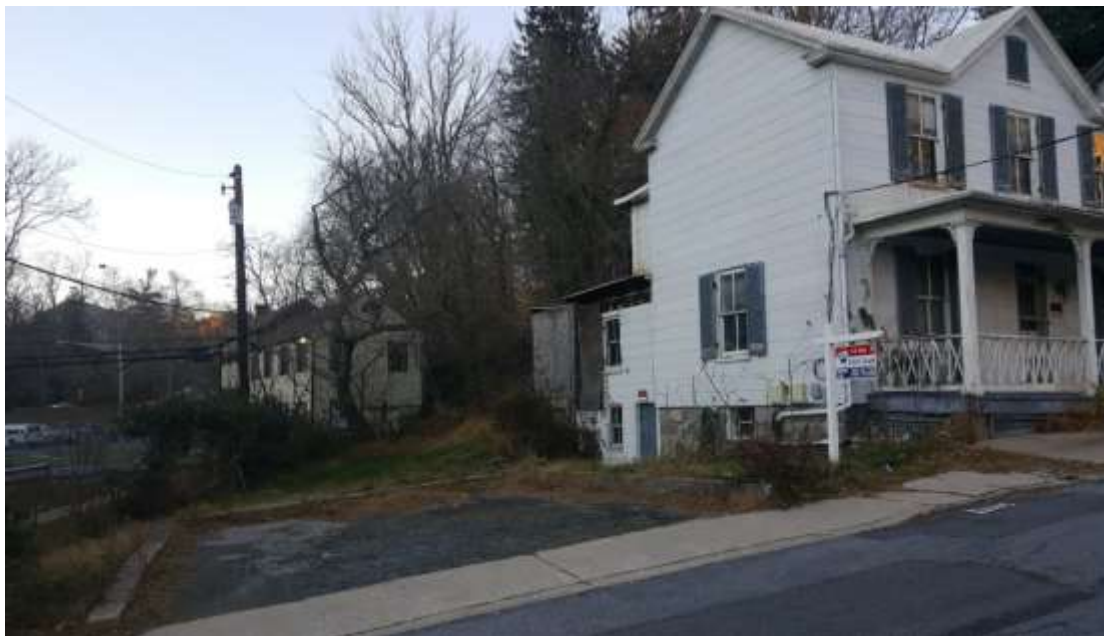
- 8) Driveway - The parcel is split zoned Historic Office (HO) and Historic Commercial (HC) and as such is exempt from parking requirements. Additionally, aerial photography from 2009 shows two cars fitting side by side on the pad. The size of the existing parking pad is similar in size to the neighboring pad at 8382 and aerial photography shows two cars in this location in 2006. Chapter 9.D of the Guidelines recommends, “where needed, install new residential driveways that are narrow (one lane) and follow the contours of the site to minimize the need for clearing and grading. If possible, locate off-street parking spaces in side or rear yards.” The existing parking pad is already large enough to accommodate two cars side by side; further enlarging the pad does not comply with the recommendations in the Guidelines. Chapter 9.D also recommends against “poured concrete...in locations visible from a public way or neighboring property.” The existing parking pad is highly visible from the public way, but is already made of asphalt. Staff recommends repaving in asphalt, which is the prominent driveway material in the vicinity.

Figure 20 - Existing driveway

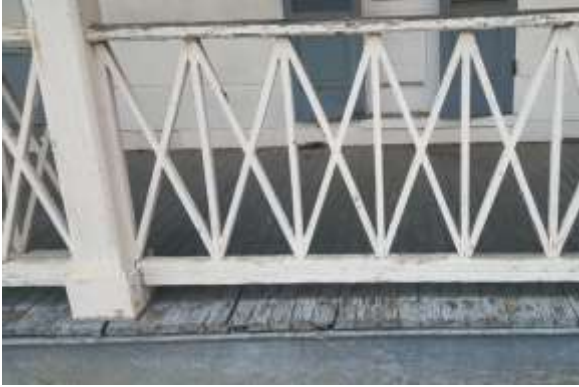
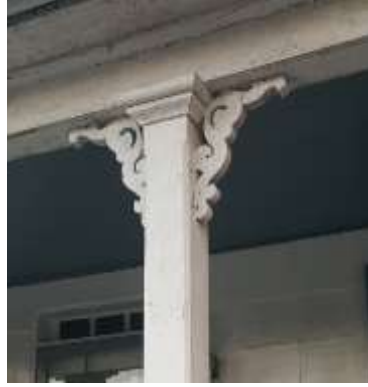
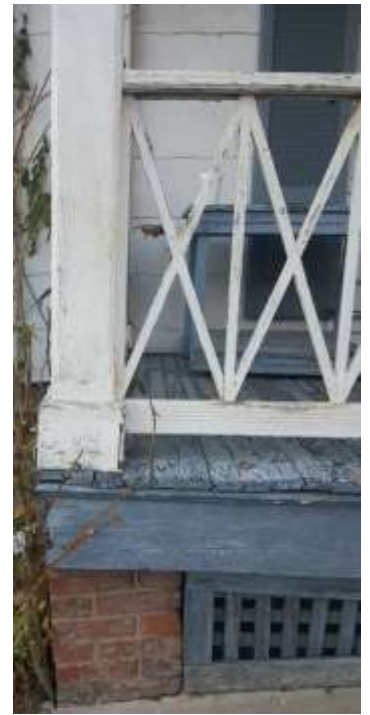
Figure 21 - Front porch railing

- 9) Front Porch – The front porch is a wood porch with an "x" pattern railing and bracketed scrolls in the corners of each post. The porch roof is a standing seam metal roof to match the rest of the house. The Applicant proposes to "replace the whole front porch due to rotten wood and severe damage all over. Existing material is wood, color is white railings and posts and grey floors." The Applicant states that they are planning to keep the same colors, styles and patterns.

- 9) Front porch - Staff does not find enough information has been submitted regarding the rebuilding of the front porch, which is a character defining element of this building. Staff recommends the Applicant return at a later date with architectural elevations that show what the porch will look like and that the front porch be withdrawn for approval at this time.

- 12) Staff recommends the Applicant withdraw the request to rebuild the front porch and make alteration/demolish the rear addition and resubmit at a later date when more information is available.

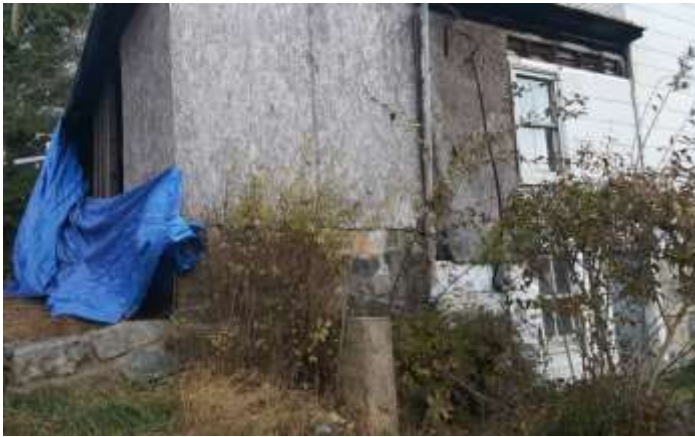
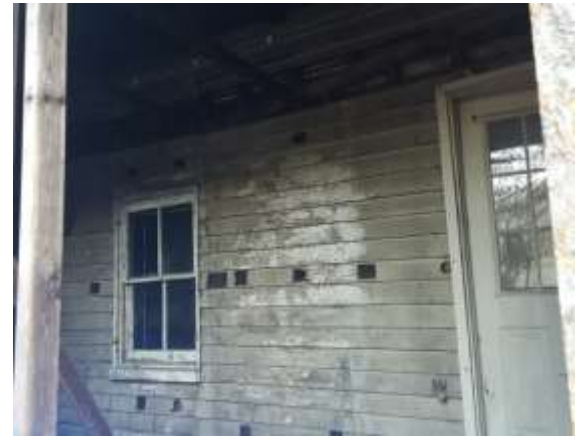
Figure 24 - Stone foundation under rear addition

- 10) Rear Addition- The rear addition the Applicant refers to was an open air porch that the previous owner started to enclose, although the work was never finished or done correctly. The Applicant proposes to demolish the existing addition and build a deck or rear porch in that location. The material for the deck would be pressure treated wood.

- 10) Rear addition - Staff finds the construction of a deck is not appropriate, given that records indicate that a porch previously existed in this location. Likewise pressure treated wood is not an appropriate material for a rear porch. Staff does not find that enough information has been submitted regarding this item and recommends the Applicant return at a later date with architectural elevations that show what the rear deck or porch will look like and that the rear addition alterations be withdrawn for approval at this time.

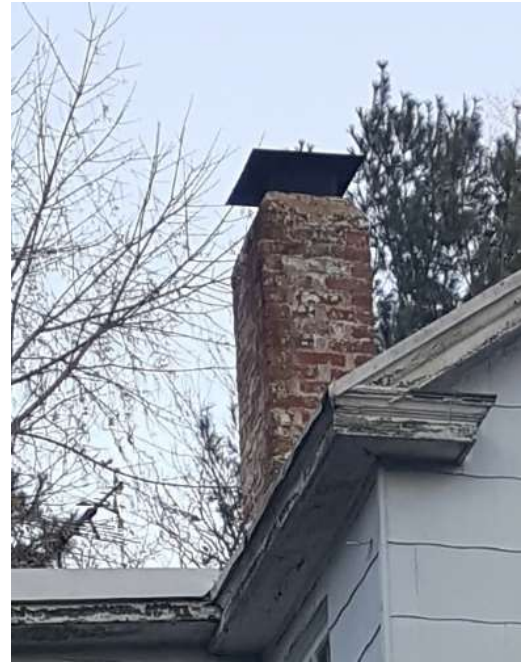
11) Additional Comments – The chimney was not listed as a repair item, but appears to be in need of repointing, replacement bricks and a new chimney crown and cap. Staff recommends tax credit pre-approval to repoint the chimney, matching the existing mortar; for the replacement of brick courses as needed, to match the existing brick, and for any other repair work, such as a new crown and cap, needed to make the chimney safe. The Applicant is not obligated to make these repairs, but may proceed if the work is pre-approved. Staff recommends the pre-approval be contingent upon a detailed scope of work, which complies with the above conditions, from a chimney/masonry professional. The repair of the chimney to match the existing brick and mortar would comply with Chapter 6.C recommendations for masonry.

Figure 26 - Condition of chimney

- 10) Tax credit pre-approval to repoint the chimney, matching the existing mortar and for any other repair work needed to make the chimney safe.
- 11) Tax credit pre-approval to repair or replace rotten wood trim, with new wood trim to match the existing in color and profile.

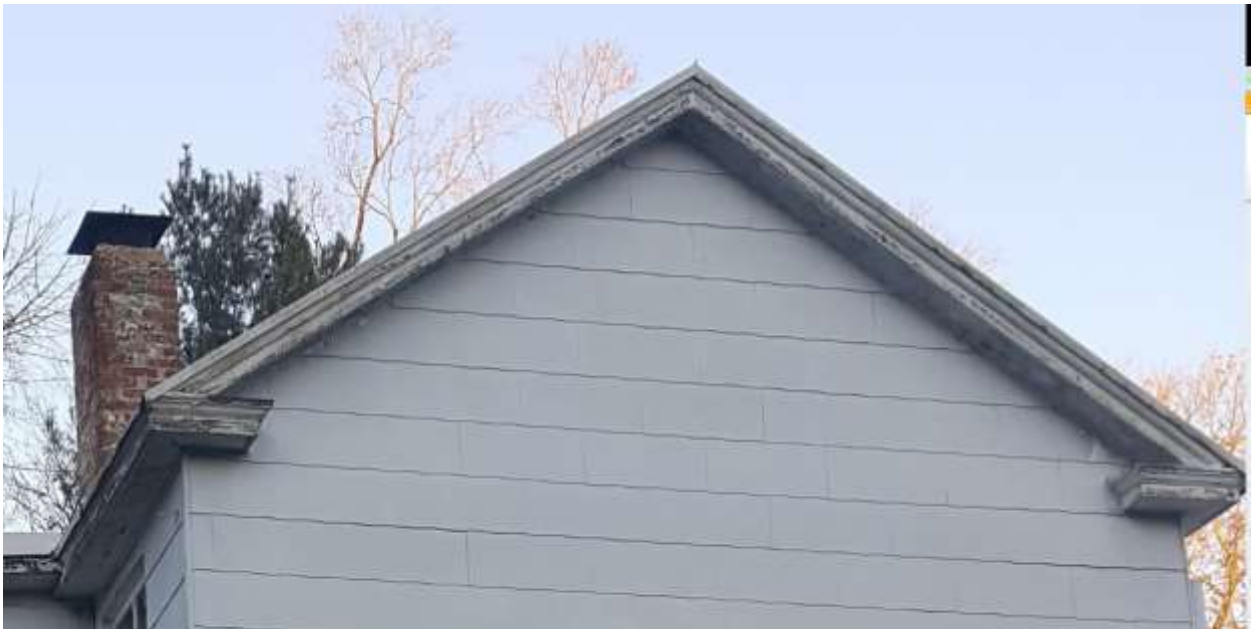
Wood trim around the house was not specifically mentioned as a repair item, but there is deterioration of the trim that needs to be repaired. Staff recommends all trim be repaired and any rotten wood be replaced in-kind with wood, painted white to match the existing. This work would be Routine Maintenance per Chapter 6.K, “maintaining and repairing cornices and ornamentation” and “replacing cornice details and ornamentation with materials that exactly match the existing materials.” However, this work does require approval for tax credits.

Figure 27 - Trim to be repaired
